An ASABE Meeting Presentation

Paper Number: 085132

Jet Test to Evaluate the Head Cutting of Glacial Till in Auxiliary Spillways in New York State

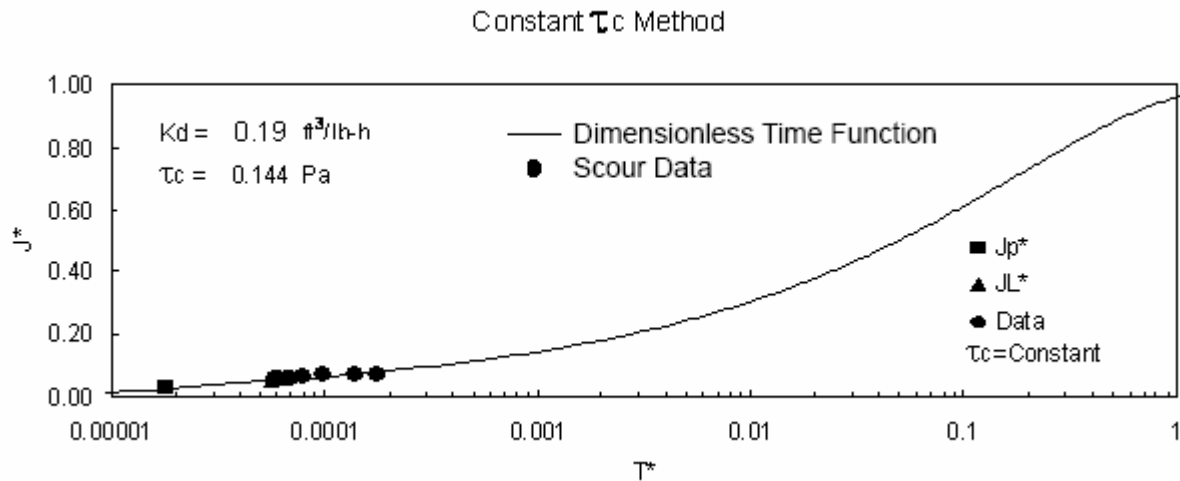
Figure 1: k_d Plot

Figure 1 shows the graphical view of the dimensionless scour function:

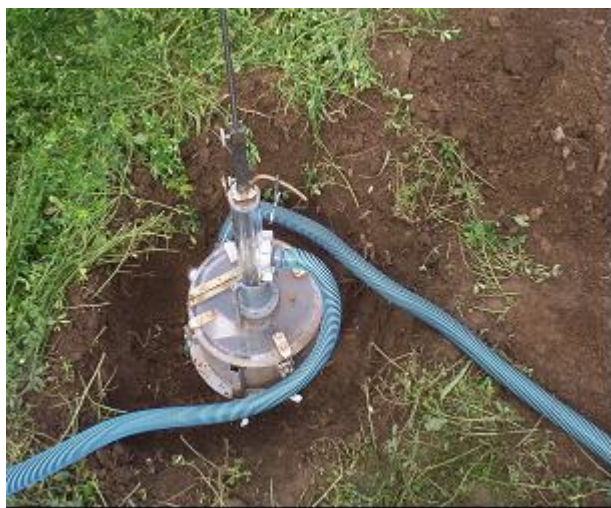
Photo 1: Jet Submergence Tank

Photograph one shows the typical setup of the jet tube, nozzle, point gage and jet submergence tank. Photograph 2 shows the adjustable head tank setup and connection to the jet submergence tank.

To set up the equipment, the base ring is pushed into the ground. A sledge hammer and a two by four are needed to set the base ring into the ground. The cover, jet tube and point gage are installed on the jet submergence tank. The head tank and 6' tubular steel used to support the tank is installed. This assembly is stabilized and kept vertical by connecting three ropes at the top of the tubular steel and connecting them to rebar driven into the soil. A 1.25 inch hose is then connected from the head tank to the jet tube. An additional 1.25 inch hose is connected to the jet submergence tank overflow. This hose should be long enough to carry water away from the test site. A garden hose connected to a gasoline powered pump provides water to the head tank from the water source. The water source used for these tests is a 1,000 gallon poly tank mounted on a trailer. Prior to starting the test, an initial reading is taken to measure the distance between the soil surface and nozzle. The pump is started and water is allowed to fill the head tank. A valve is opened at the head tank to allow water to fill the jet tube and the jet submergence tank. Any air trapped in the jet tube is released by opening the air relief valve.
